Technical Report CHL-97-13  
July 1997

*Monitoring Completed Navigation Projects Program*

## **Monitoring of Harbor Improvements at St. Paul Harbor, St. Paul Island, Alaska**

by *Robert R. Bottin, Jr., WES*  
*Kenneth J. Eisses, Alaska District*

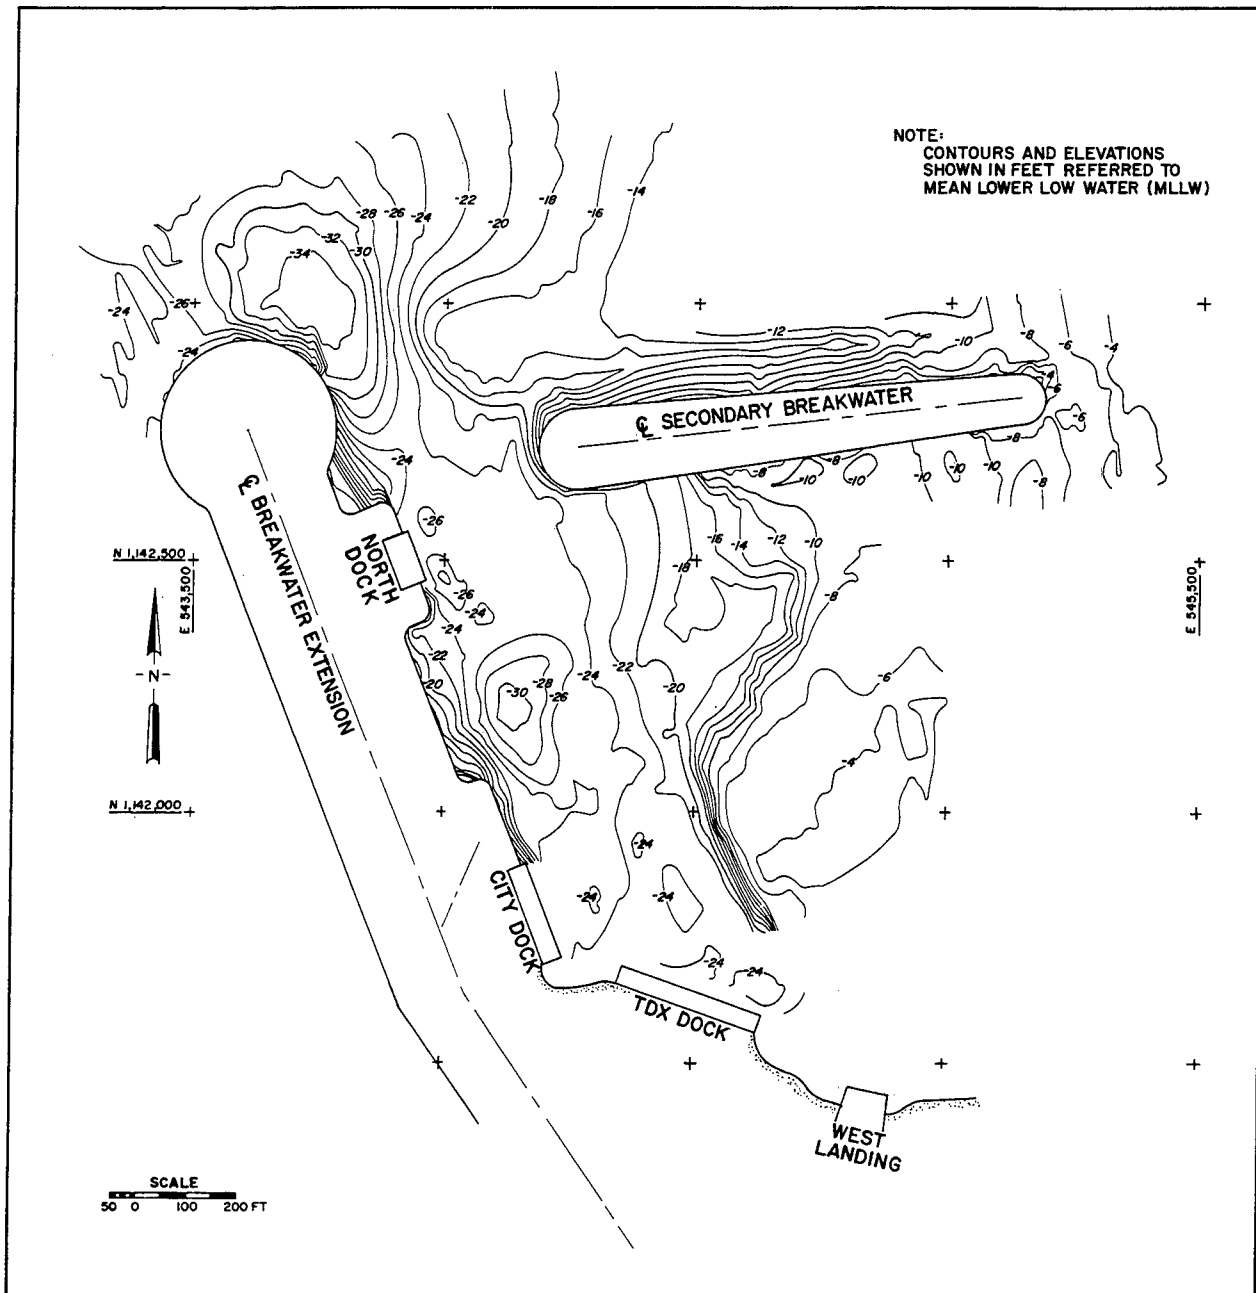
Figure 25. Bathymetry at St. Paul Harbor, August 1992

Bathymetric data obtained in August 1992 (after breakwater improvements) are shown in Figure 25. A 10.4-m (34-ft) scour hole formed adjacent to the head of the new main breakwater extension similar to the one formed after the original breakwater was constructed. The scour hole did not appear to have significantly undermined or impacted the stability of the structure head. Depths in the harbor between the northernmost dock and City Dock were greater than the 5.5-m (18-ft) authorized federal channel and maneuvering area, and therefore, dredging was not required after construction. Local interests did, however, dredge an area in the harbor adjacent to the TDX dock. Note the change in contours north of and adjacent to the detached breakwater. Sediment began accumulating against the structure.

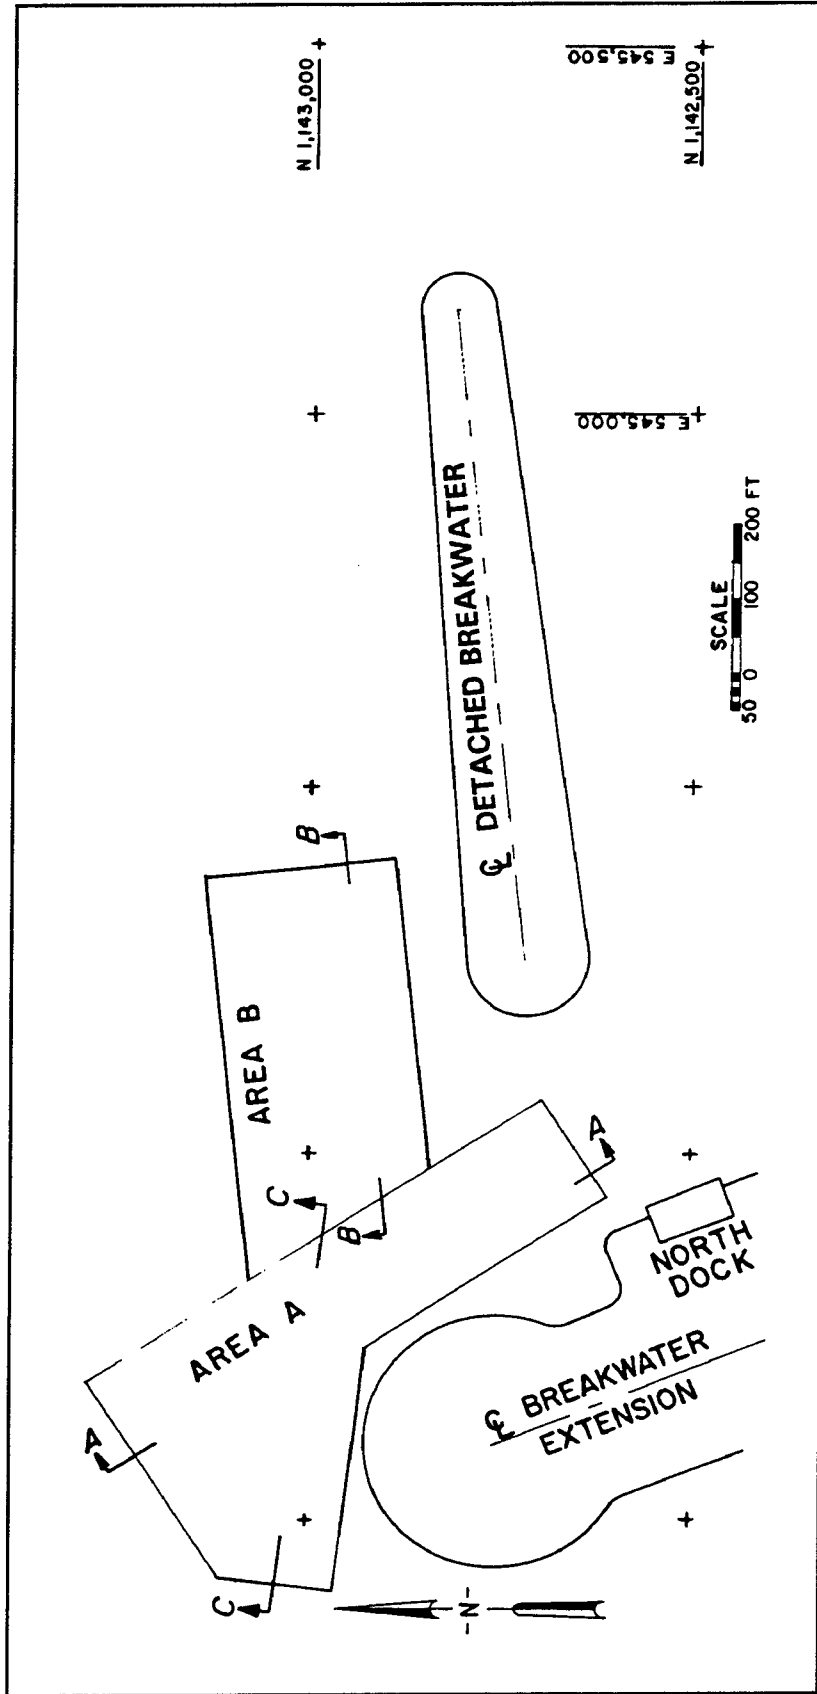
Figure 29. Areas at harbor entrance selected for detailed analysis

In an effort to better quantify scour and fill conditions at the harbor entrance, two areas were selected for more detailed analysis. Figure 29 presents the areas identified. Area A consists of 15,500 sq m (166,800 sq ft) and was initially used to determine scour adjacent to the head of the breakwater extension; Area B includes 11,770 sq m (125,700 sq ft) and was used to depict accretion across a portion of the entrance. Detailed bathymetry (0.3-m (1-ft) intervals) for Areas A and B are shown in Figures 30 through 32 for the 1986, 1992, and 1995 surveys, respectively; and

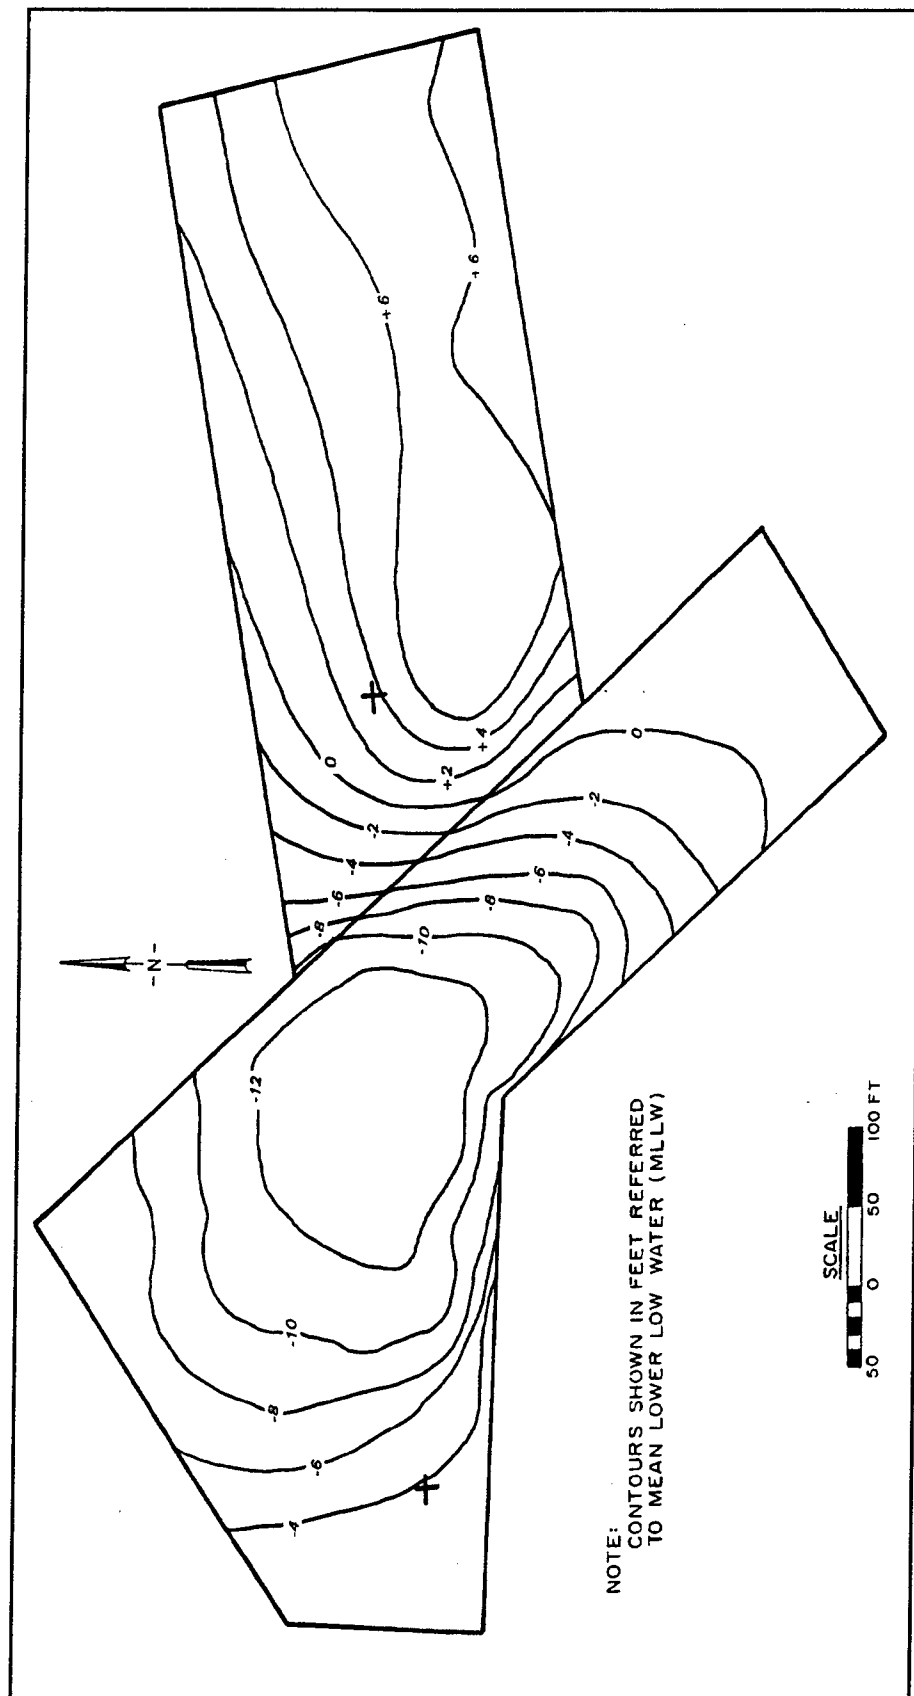
Figure 36. Contours of bathymetric changes in Areas A and B between September 1986 and August 1992 surveys

cross sections through Areas A and B (at locations shown in Figure 29) are presented in Figures 33 through 35 for the various surveys. Contours of bathymetric changes that occurred between September 1986 and August 1992 are shown in Figure 36, and those occurring between August 1992 and July 1995 are presented in Figure 37. Erosion and accretion volumes were calculated for each area. Results indicate that, during the period 1986 through 1992, approximately 31,960 cu m (41,800 cu yd) of scour occurred in Area A and about 13,070 cu m (17,100 cu yd) of accretion occurred in Area B. This was the result of post-breakwater modifications. Between 1992 and 1995, Area A accreted about 4,660 cu m (6,100 cu yd) and Area B accreted approximately 5,350 cu m (7,000 cu yd) of material. Net volumes (between 1986 and 1992) are 27,300 cu m (35,700 cu yd) of scour in Area A and 18,420 cu m (24,100 cu yd) of fill in Area B.

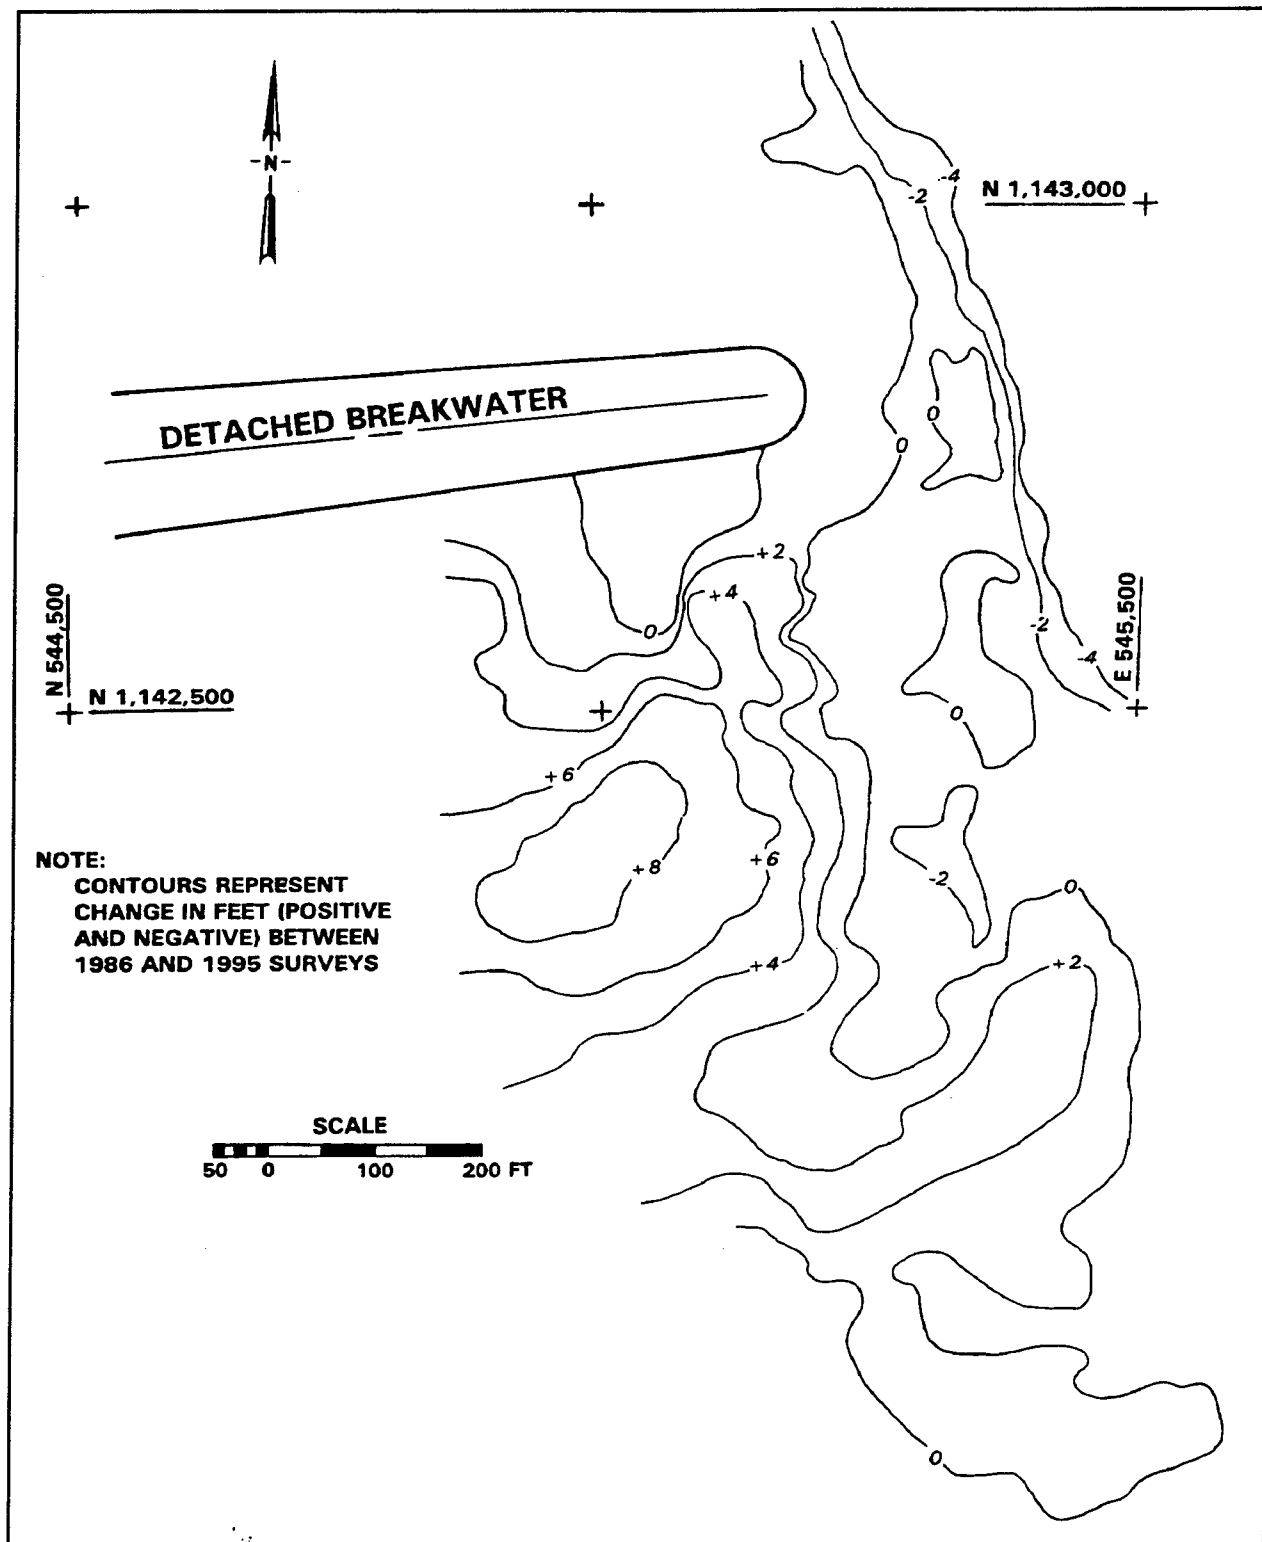
Figure 38. Contours of bathymetric changes in the lee of the eastern end of the detached breakwater between September 1986 and July 1995

The July 1995 survey was more comprehensive than the August 1992 survey in that it included more bathymetry inside the harbor. To determine changes as a result of the opening between the detached breakwater and the shoreline, the July 1995 survey was compared to pre-breakwater conditions (September 1986 survey). Contours of bathymetric changes in the lee of the eastern portion of the detached breakwater were prepared. Data indicate accretion of 2.4 m (8 ft) in areas inside the harbor between 1986 and 1995, as shown in Figure 38.

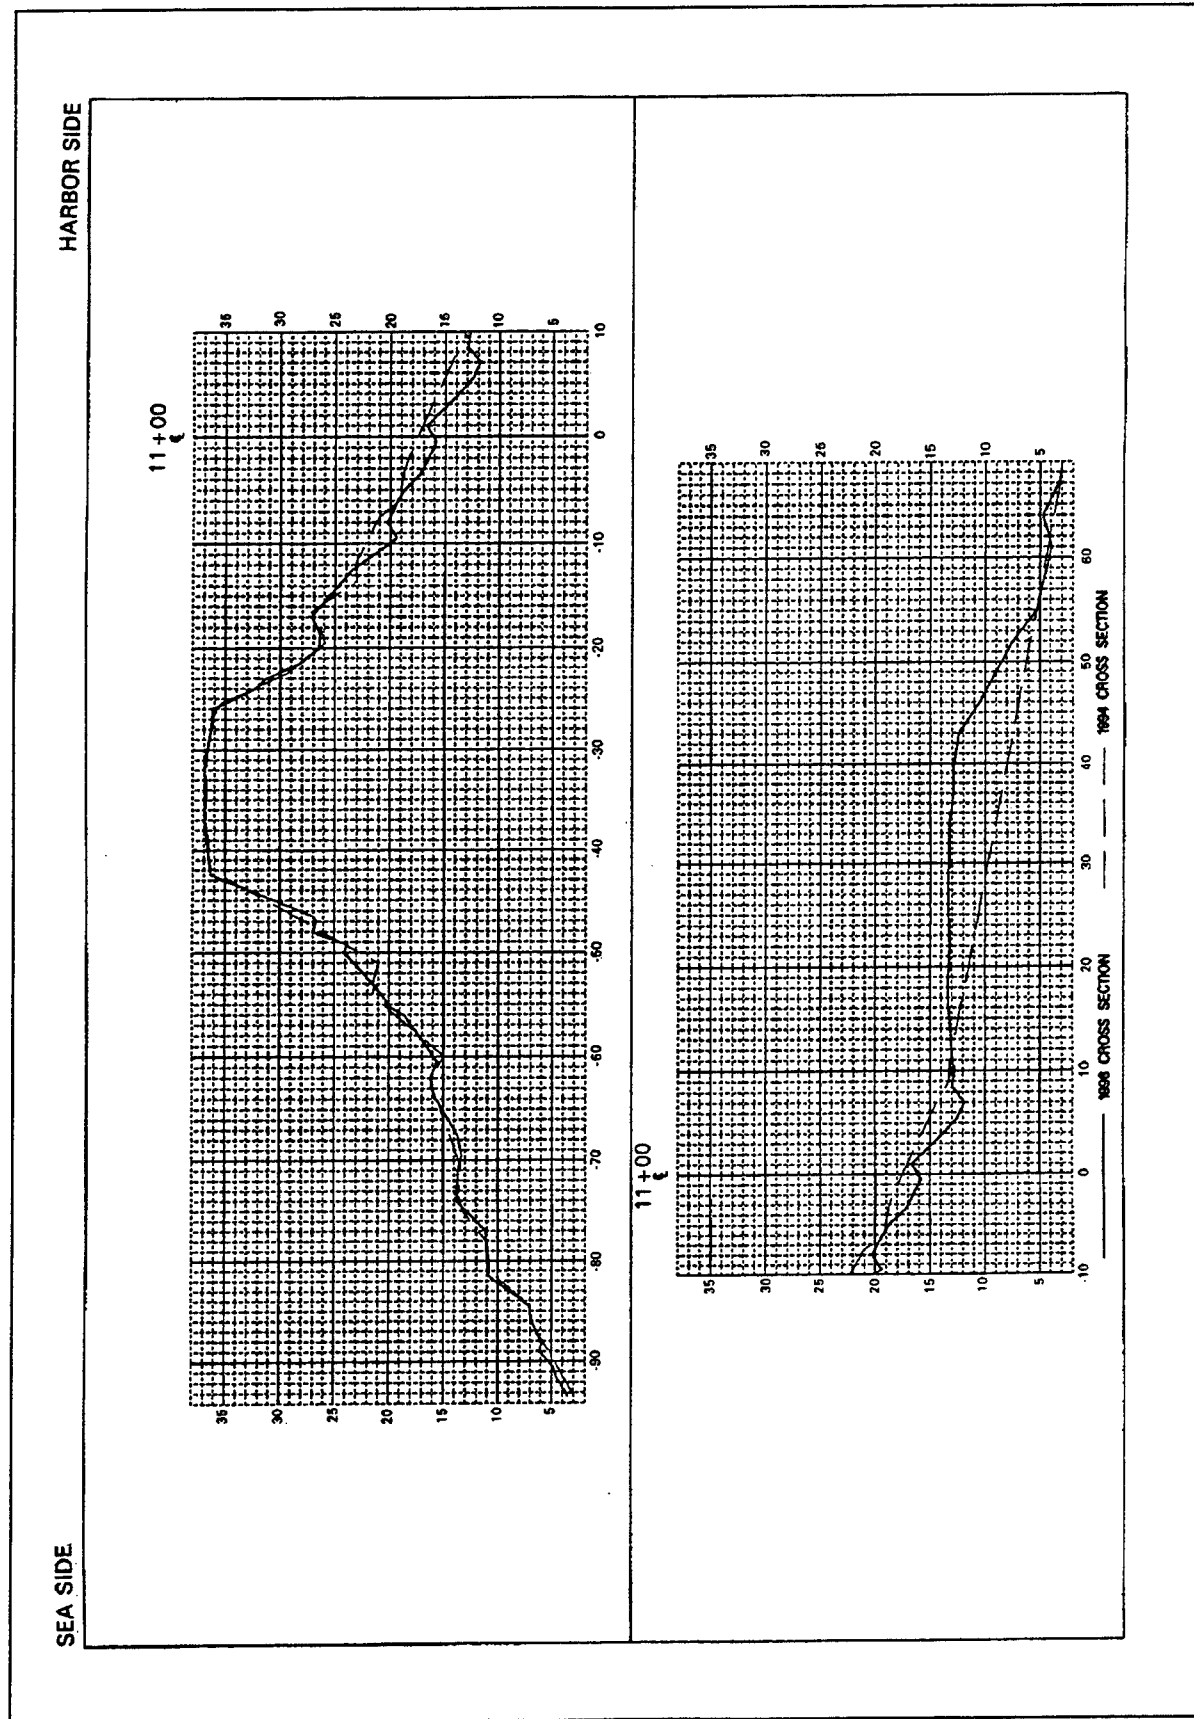
Figure C3. Cross sections of St. Paul Harbor main breakwater, sta 11+00

Examination of the data in Appendix C reveals that cross sections of the breakwater were similar in both 1994 and 1996. Accretion of stone along the toe of the harbor-side slope of the structure is shown at stas 11+00, 12+00, and 13+00. This was an accumulation of small stones which were noted during the 1996 broken armor stone survey. CENPA personnel inspected the breakwater in November 1996 after a large storm and determined the small stones coming out of the structure were chinking stone used during breakwater construction. Approximately a 1.8-m (6-ft) layer of this small stone was placed directly under the armor layer during construction.
